NRPA Bulletin

Radiation Protection in the Andreeva Bay

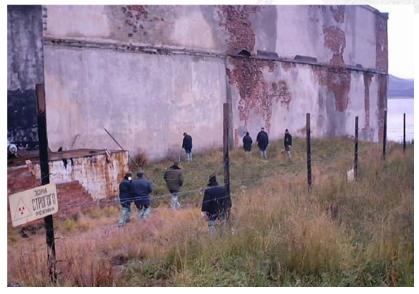
Making measurements and sampling at "Buliding 5" (Photo: SevRao)

The Norwegian Radiation Protection Authority (NRPA) is implementing a project, "Radiation Protection in Andreeva Bay", to map radiation levels in the area and analyse ground contamination. In the course of the autumn 2002 about 2,000 measurements and 245 soil samples were taken.
